3

Effects of Road Salt on Motor Vehicles and Infrastructure

Road salt's impacts on motor vehicles and infrastructure are examined in this chapter. The focus is on three major areas: motor vehicles, bridges, and parking garages. Impacts on other infrastructure components, such as pavements, underground utilities, and road-

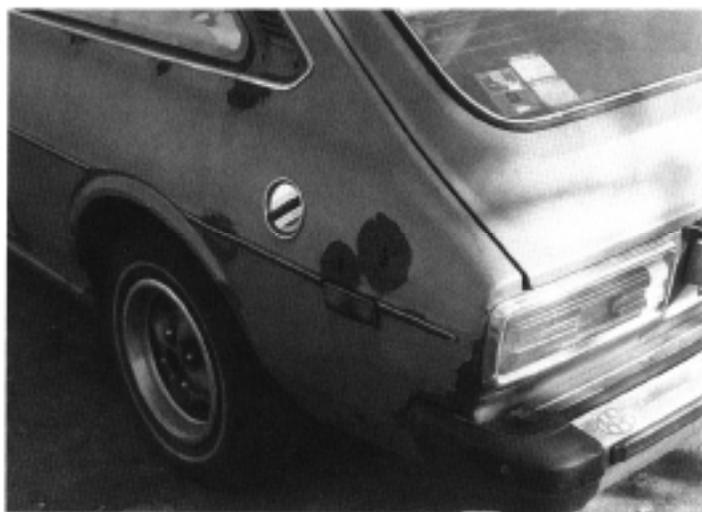
FIGURE 3-1 *Top:* Structural corrosion (perforations). *Bottom:* Cosmetic corrosion.

Corrosion damage to motor vehicles can be separated into three categories: functional, structural, and cosmetic. Functional and structural damage occur when corrosion causes a loss of operating performance or structural integrity. Examples include perforation of body panels (Figure 3-1), corrosion of brake linings, and deterioration of the frame and bumper support systems. Cosmetic corrosion affects only the appearance of the vehicle. Examples include rust staining of painted body panels and discoloration and pitting of trim metals (Baboian 1990, 1-2).

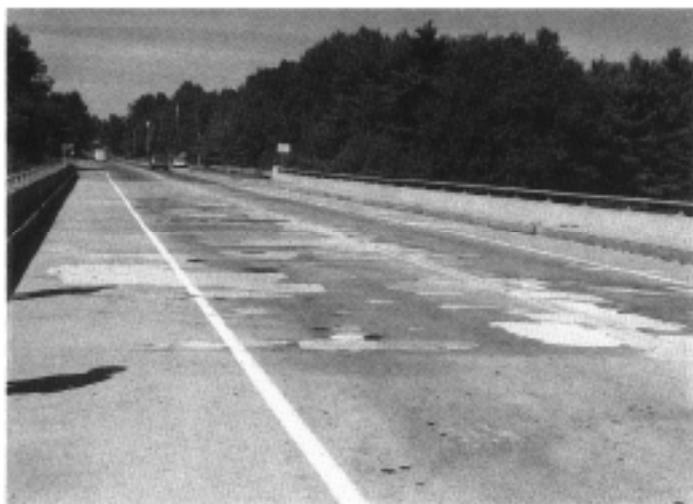
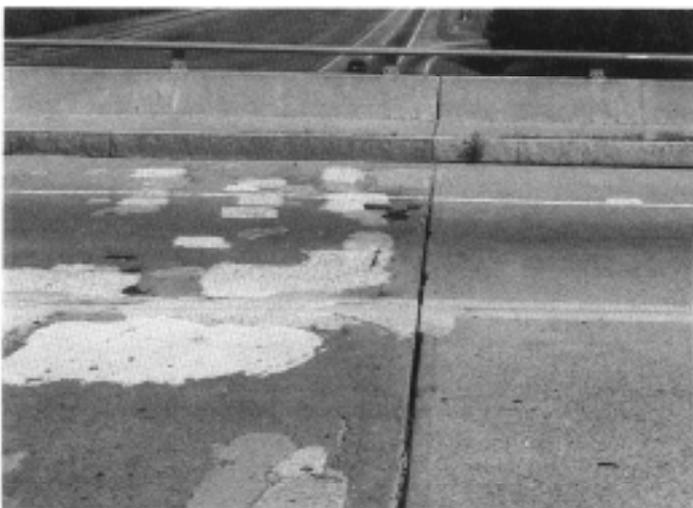
FIGURE 3-5 Patching of a severely contaminated concrete deck.

Conventional methods of deck repair range from patching of individual potholes during early stages of deterioration to complete deck replacement if potholes and patches cover a large portion of the deck. Because of its low cost, patching is the most common repair, although its effectiveness is usually only temporary (Figure 3-5). To provide longer-lasting repair, the damaged concrete must be replaced with new concrete and special waterproof membranes or sealers that prevent further intrusion of salt and moisture. Such partial restoration, however, is seldom completely successful in halting the corrosion process, because unrestored sections often begin to corrode after the deck has been repaired.

A disadvantage of partial deck restoration is that signs of corrosion, such as potholes, may not become evident until well after a large portion of the deck has become critically contaminated with chlorides. Once this critical, or threshold, contamination level has been
